ENTRYWAY ROUNDABOUT
REVIEW OF OPERATION & SAFETY

For the City of Clearwater

Robert Barry Crown, B.Sc. C.Eng. M.I.C.E
Rodel Software Ltd

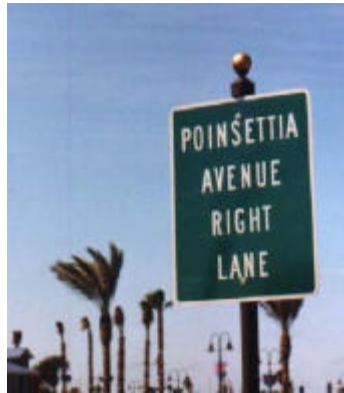
The existing Lane Use Signs are too small to be effective and should be replaced.

Two sets of larger Lane Use Signs are needed on the Mandalay Avenue and Coronado Drive and three sets are required on the Causeway.

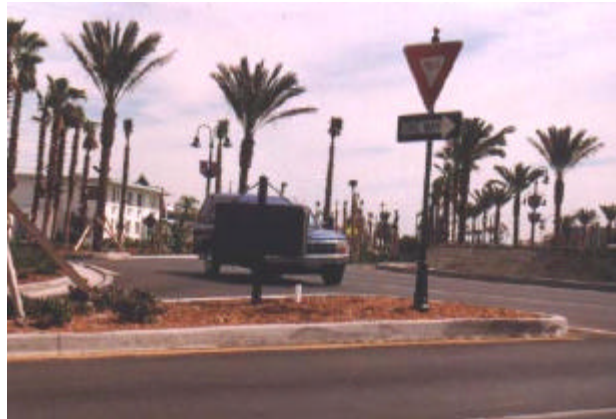
Currently some of these signs are obstructing the view to the left of drivers at the yield line waiting to enter the roundabout. This should be corrected by raising the height of the signs as lowering them make them less visible to the circulating traffic, especially at the Coronado exit where the fountain wall would obstruct the drivers view of a low sign until vehicles are too close to the exit. If the height of the fountain wall is reduced the signs could be lowered and still be visible.

Sign Blocking View to the Left

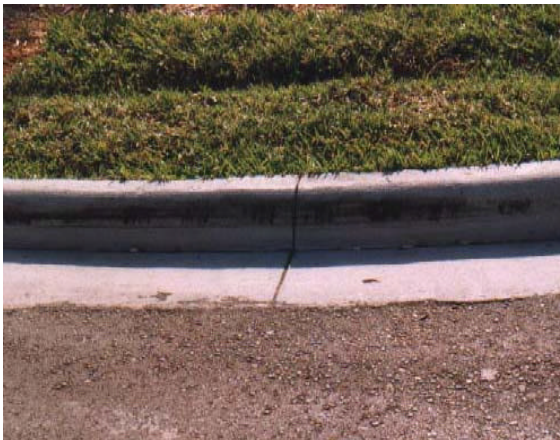
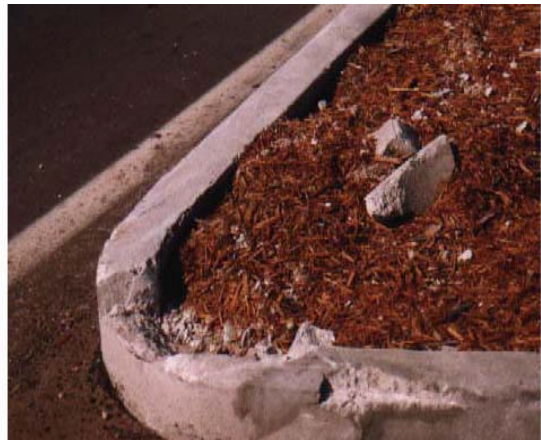
The roundabout entry and exit geometry is very constricted to maximize pedestrian safety by controlling traffic speeds. Speeds are very low, but the restricted geometry has resulted in trucks scrubbing and damaging the curbs.

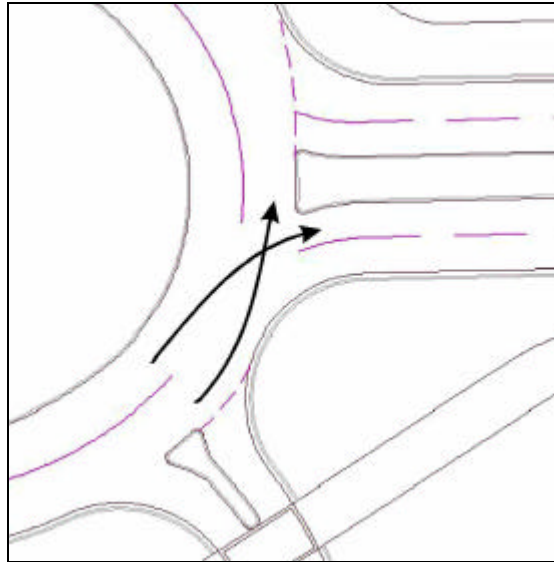
It is incorrect and dangerous for drivers to use the outside lane of the roundabout to cross a **multiple-lane exit**. However, some drivers from Coronado or Mandalay are using the outside lane to pass the **two-lane exit** at the Causeway.

These vehicles cut across vehicles on the inner lane of the roundabout that are correctly exiting onto the Causeway. This has led to a concentration of crashes at this location.

Progress past the Causeway exit can only be made safely from the inner lane of the roundabout.

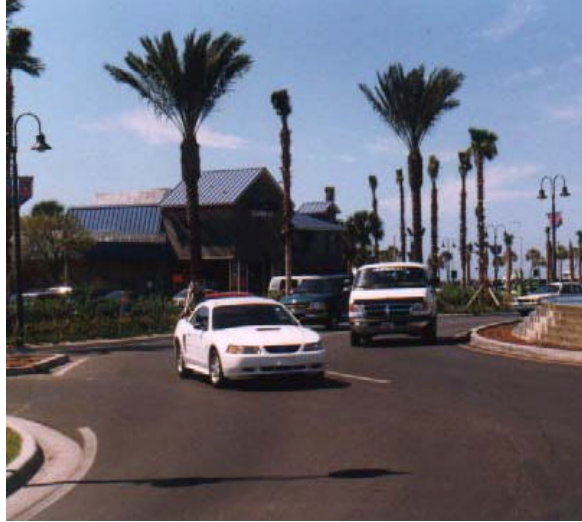
Approaching the Causeway exit, the **left curved** geometry of the outer curbing, together with the large exit angle and small exit radius onto the Causeway, combine to give drivers the strong impression that driving past the Causeway exit in the outer lane is natural and correct.

Driving in the outer lane across the Causeway Exit and crossing the path of an exiting vehicle from the inner lane

Modifications to the exit geometry, the striping, the lane signs together with the addition of lane direction arrows, will make it clear to drivers that the outer lane is solely for exiting onto the Causeway. Drivers will cease to travel past the Causeway exit in the outer lane, or in rare cases when they realize they are in the wrong lane, they will take extreme caution to avoid collision with exiting vehicles.

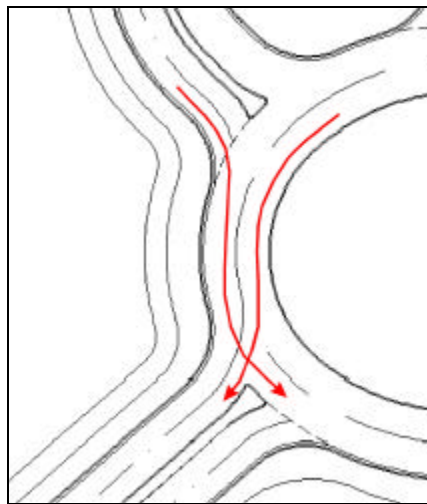
When a vehicle is on the inner lane of the roundabout, and the outer lane is empty, a vehicle from Mandalay can **safely** enter the outer lane of the roundabout **without yielding**.

The paths of the two vehicles **do not cross**. The Mandalay vehicle makes a **merge** into the outer lane with no **entry conflict** with the inner lane vehicle. This is very undesirable as the absence of the **entry conflict** can subsequently create a dangerous **exit conflict**.

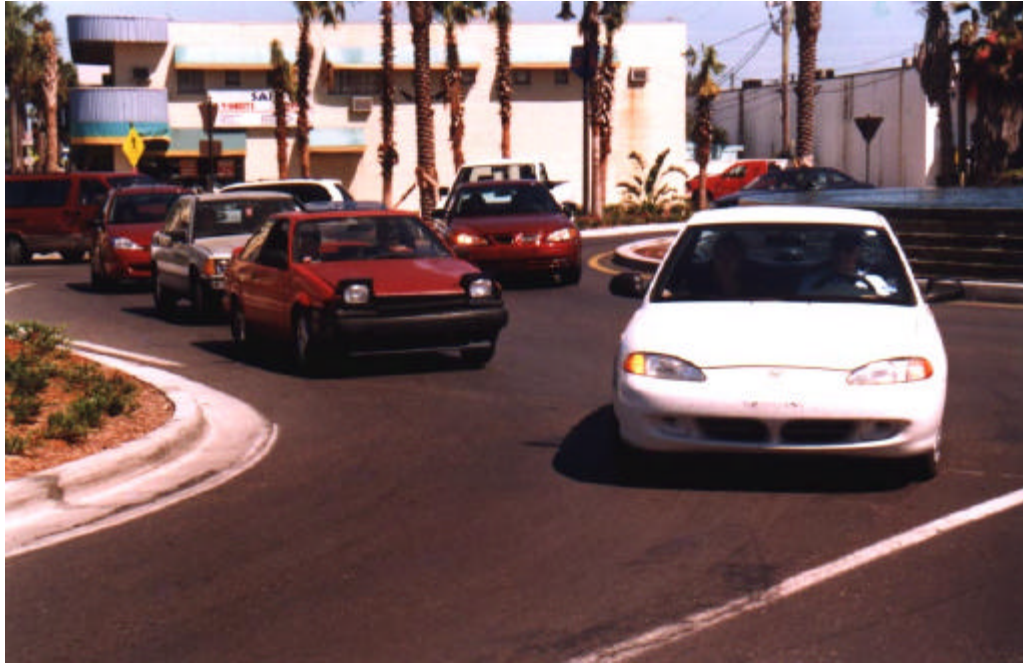
The two vehicles proceed **side by side** for about 75ft until they reach the exit of Coronado. If the outer vehicle proceeds when the inner vehicle exits, their paths suddenly cross creating an

exit conflict and a crash is likely to occur. Neither has priority over the other, nor do they know the others intention until the last second, when it can be too late.

Exit conflict at the exit into Coronado Drive.
The white car exits into Coronado across the path of the non exiting red car

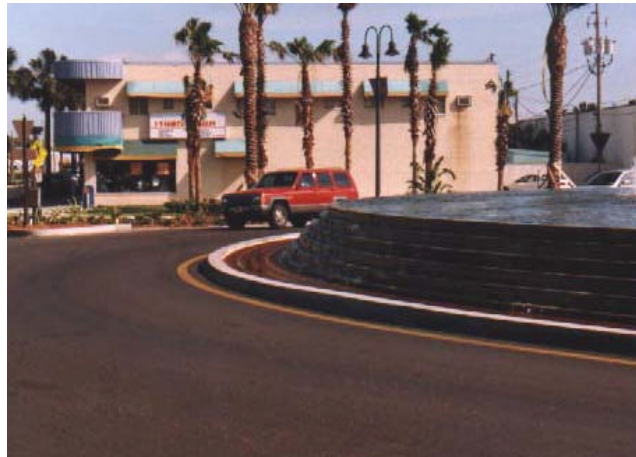
The Entryway Roundabout has sight stopping distances far greater than 77 feet over most of the length of the circulating road. It has a minimum sight stopping distance of 83ft at the small radii at the ends of the central island. The proposed 2.5ft wide striped apron around the central island will increase this minimum value from 83ft to 93ft, well within the safety requirement. If the height of the Fountain Wall is reduced by one foot (two steps) then the sight stopping distance will be further increased.

Although the Fountain Wall complies with the Safety Standards, it is very close to the edge of the roundabout and produces a ‘canyon’ effect. This is uncomfortable for some drivers on the inner lane. They have a tendency to shy away from the central island and sometimes elect to use the outer lane. They may feel more comfortable, but they may be in the wrong lane and this may contribute to exit conflict.

This situation can be eased by reducing the width of the circulating lanes to 14 feet wide to provide a 2.5 foot wide striped apron around the central island. This will move traffic away from the Fountain Wall and make the inner lane more comfortable to drive.

If the height of the wall is reduced from a height of three feet to two feet (by two steps), the 'canyon' effect will be removed. The 1.5inch margin for the main sight distance will be increased to about 12 inches. As this will make it much more comfortable for drivers it is recommended that the wall be lowered. However, this will be costly and is not required by the Safety Standards so the decision to lower the wall could be deferred until after the roundabout is modified and its performance monitored.
