ENTRYWAY ROUNDABOUT
REVIEW OF OPERATION & SAFETY

For the City of Clearwater

Robert Barry Crown, B.Sc. C.Eng. M.I.C.E
Rodel Software Ltd

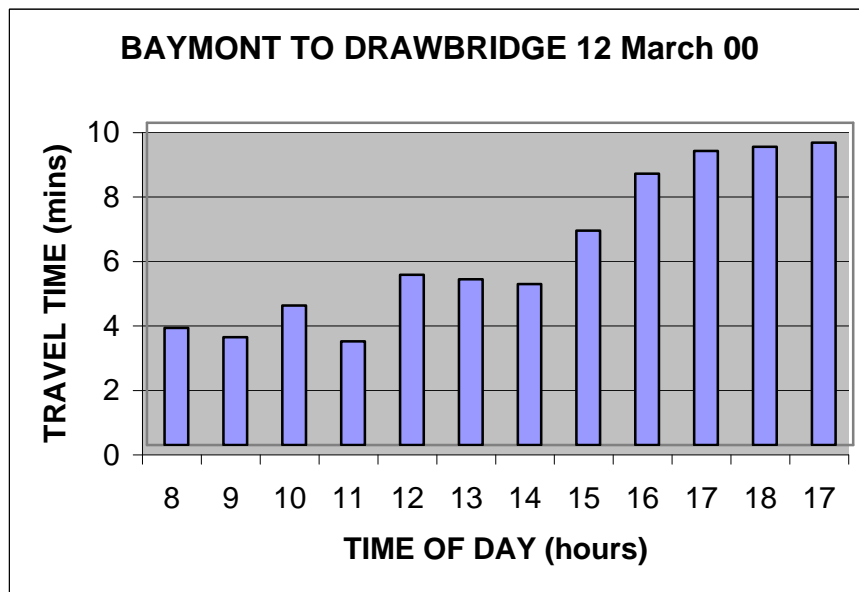
The longest travel times were recorded on 12th March 2000 during the abnormally high Spring Break traffic volumes.

The following chart gives the travel time (minutes) between 8:00 and 17:00 for each intervening hour of the day;

The Travel Times are below 5 minutes until midday, when they slowly rise to about 9.5 minutes.

The police reduced these delays by metering the traffic from the Causeway on subsequent days. This could be done by some form of signal controlled metering.

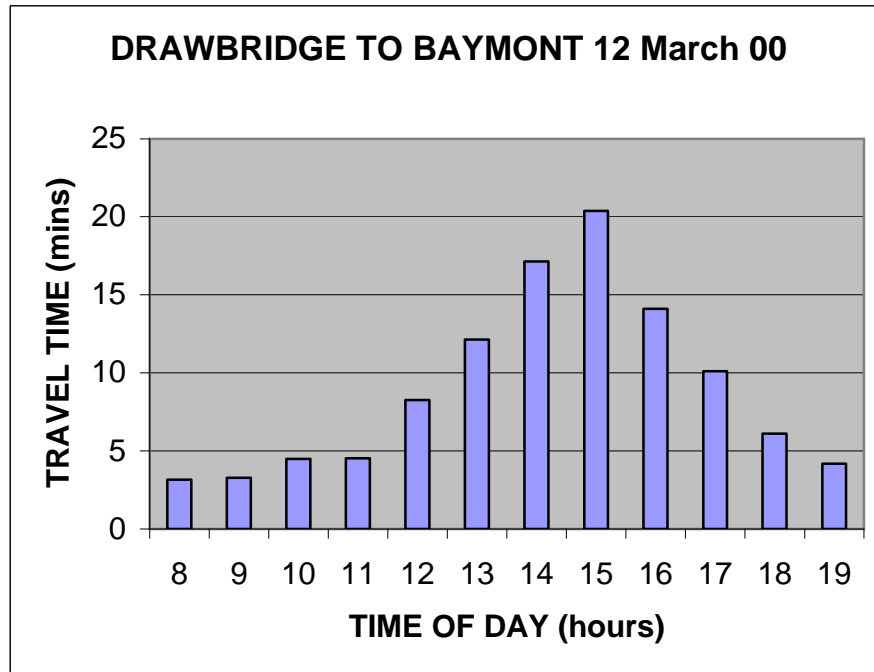
The reverse travel-times from the western end of the Drawbridge to Baymont is shown in the Chart below;

The travel times are below 5 minutes until midday when they rise steeply to just over 20 minutes by 15:00 PM.

The metering will increase these delays a little between 15:00 and 18:00. However, it is unlikely that the queues will reach the mainland, as queue ‘compression’ will absorb the short stop time at the metering signal.

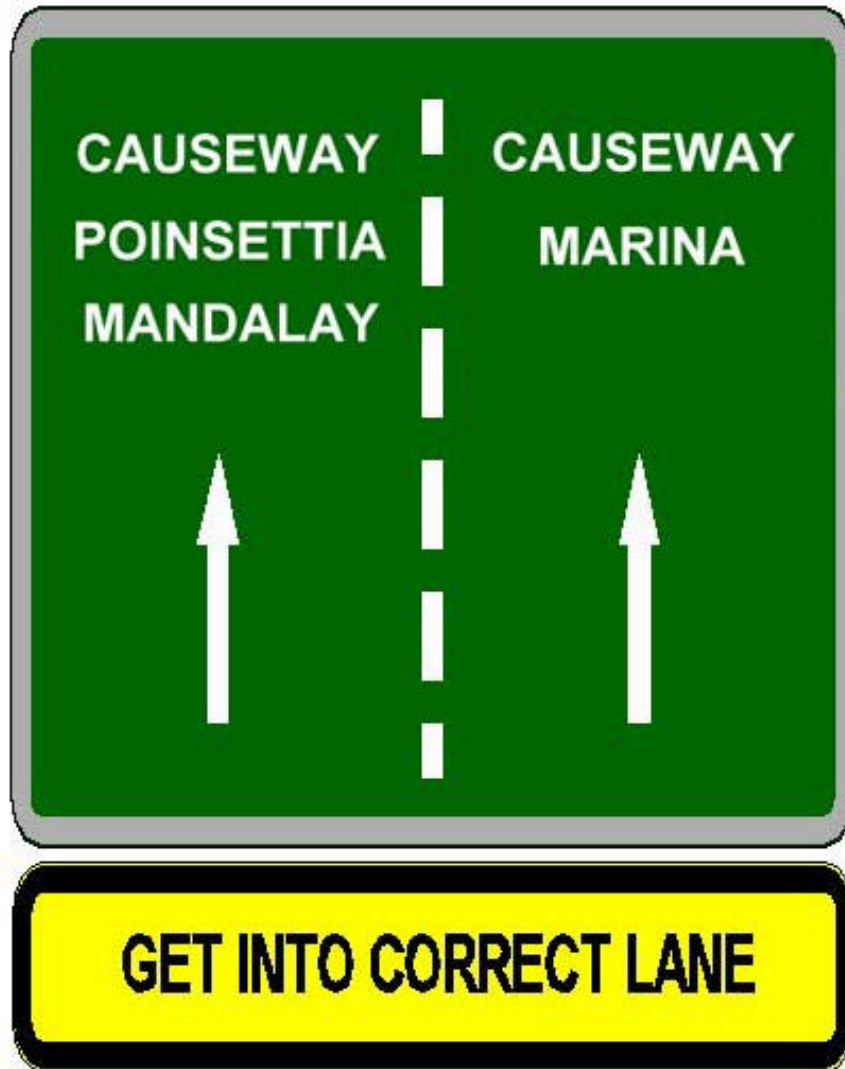
1. CORONADO DRIVE

The existing Lane Use Signs are too small to be effective and should be replaced.

Two sets of larger Lane Use Signs are needed on the Mandalay Avenue and Coronado Drive and three sets are required on the Causeway.

The sign is 4 feet tall and 3 feet wide.

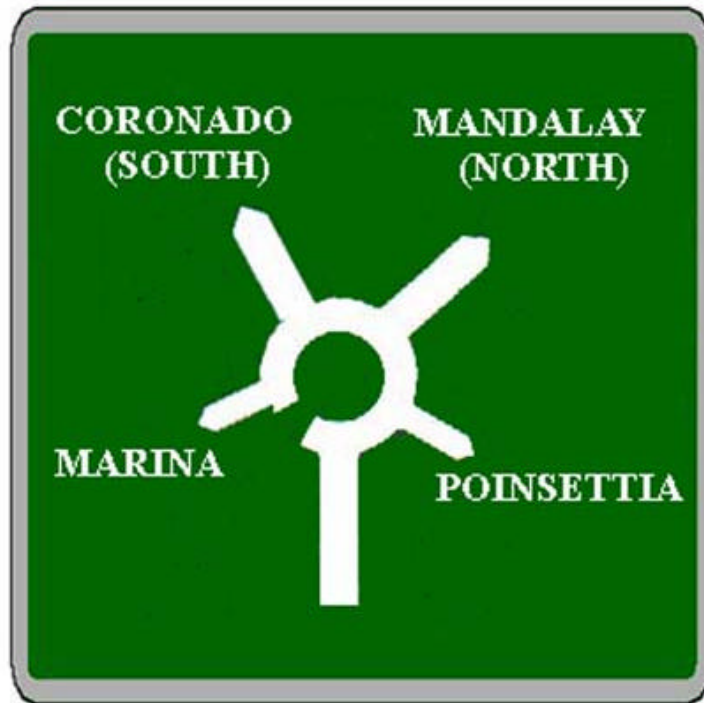
APPENDIX 3 – THE CAUSEWAY ADVANCED DIRECTION SIGN

The Advanced Direction Sign on the Causeway needs to be replaced with a larger more conspicuous sign. The lettering especially needs to be larger so that it is easily read by approaching drivers. Advanced Direction Signs should also be introduced on Coronado Drive and Mandalay Avenue.

The lettering on the sign should be as large as possible and be between 3 and 12 inches tall.

The primary destinations, Coronado and Mandalay, are depicted by wider road widths and longer road sections. The lettering for the primary destinations can also be larger than the secondary destinations.

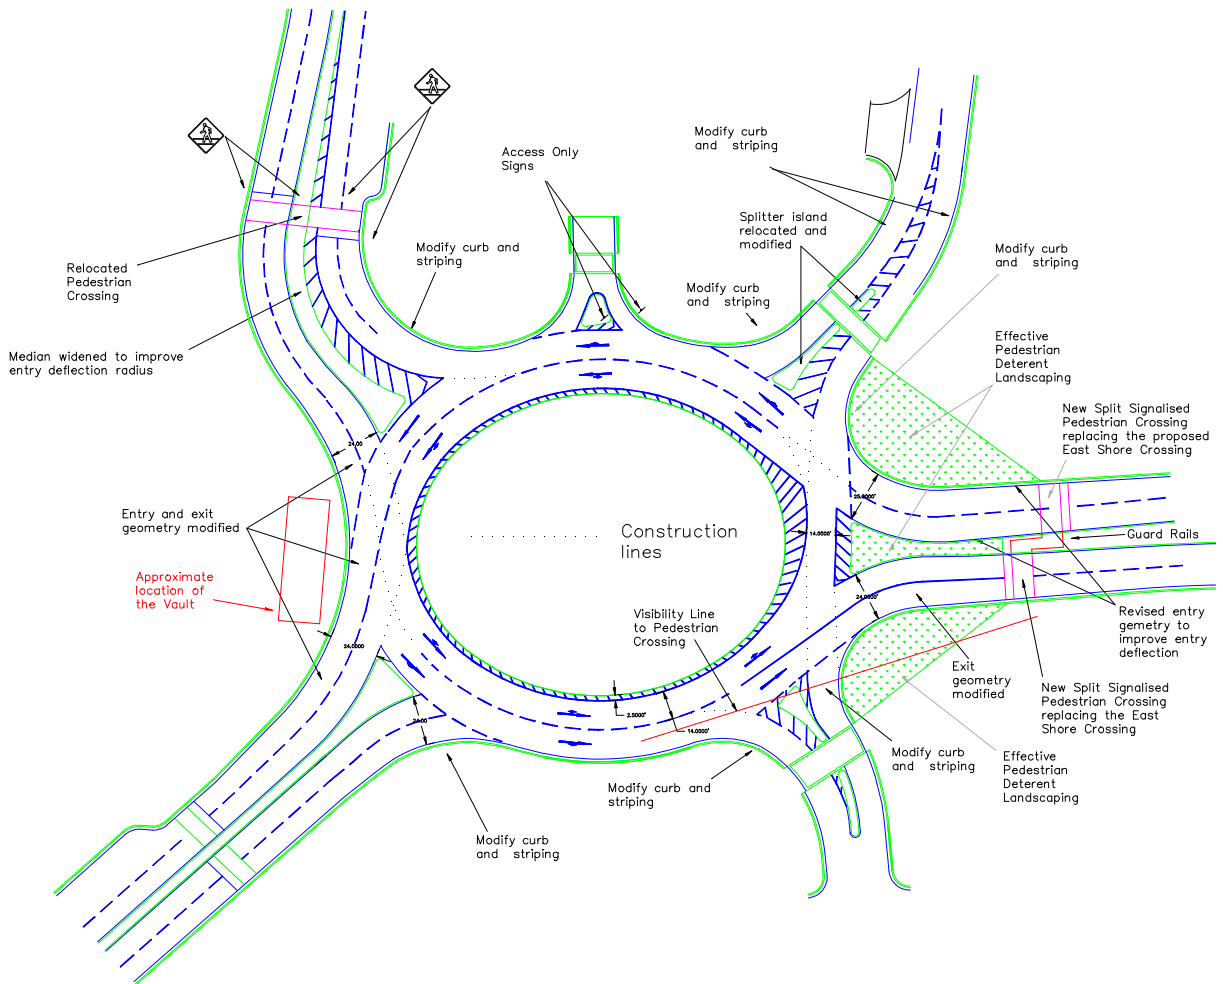
FINAL LAYOUT

The constricted geometry has also contributed to the driver discomfort and vehicle exit accidents at Coronado Drive and at the Causeway.

It is incorrect and dangerous for drivers to use the outside lane of the roundabout to cross a **multiple-lane exit**. However, some drivers from Coronado or Mandalay are using the outside lane to pass the **two-lane exit** at the Causeway.

These vehicles cut across vehicles on the inner lane of the roundabout that are correctly exiting onto the Causeway. This has led to a concentration of crashes at this location.

It recommends changes to the geometry, signing and striping of the roundabout. As a consequence, additions and changes are required to the pedestrian crossings to maintain pedestrian safety. The changes recommended are illustrated in the accompanying CAD drawings in Appendix 4.
